| BF29 | 31N | 48° 28.0627'N |
| Old burned abandoned house/scattered dump located in the coulee. | | Site located behind Newtown housing in nearby coulee. |
| <b>Site Inventory Date</b> | <b>Known / Potential Environmental Concerns</b> | |

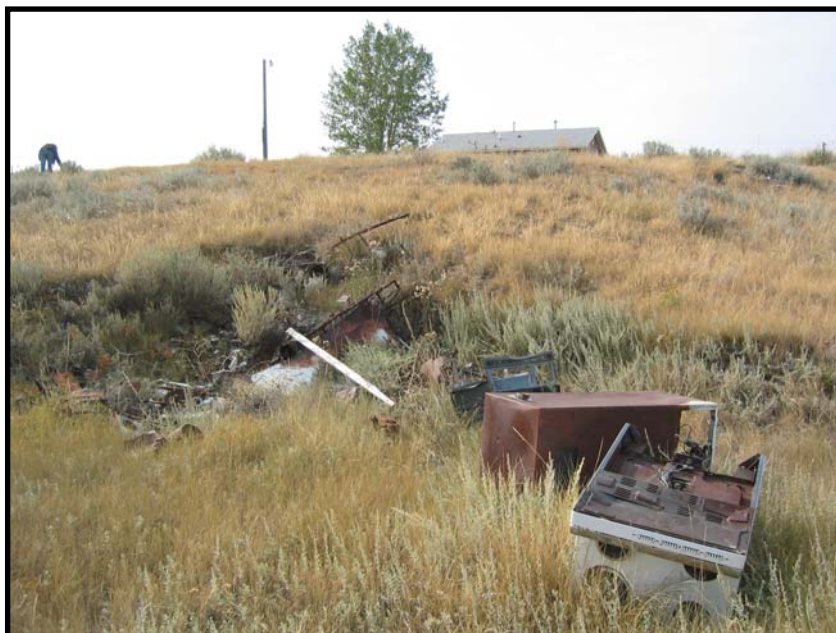
| 09/07/2006 | Comments: Community dump with household waste, appliances, metal debris, plastics, mainly household waste, and household appliances, and there are possible old junk vehicles located further down the coulee from the site. Runoff from storm events drainage flows into coulee and into stream and there is a pond located further up from the coulee. | |
